Redlands Boulevard and Hemlock Avenue Gas Station Project

MSHCP Consistency Analysis and Habitat Assessment

September 2021

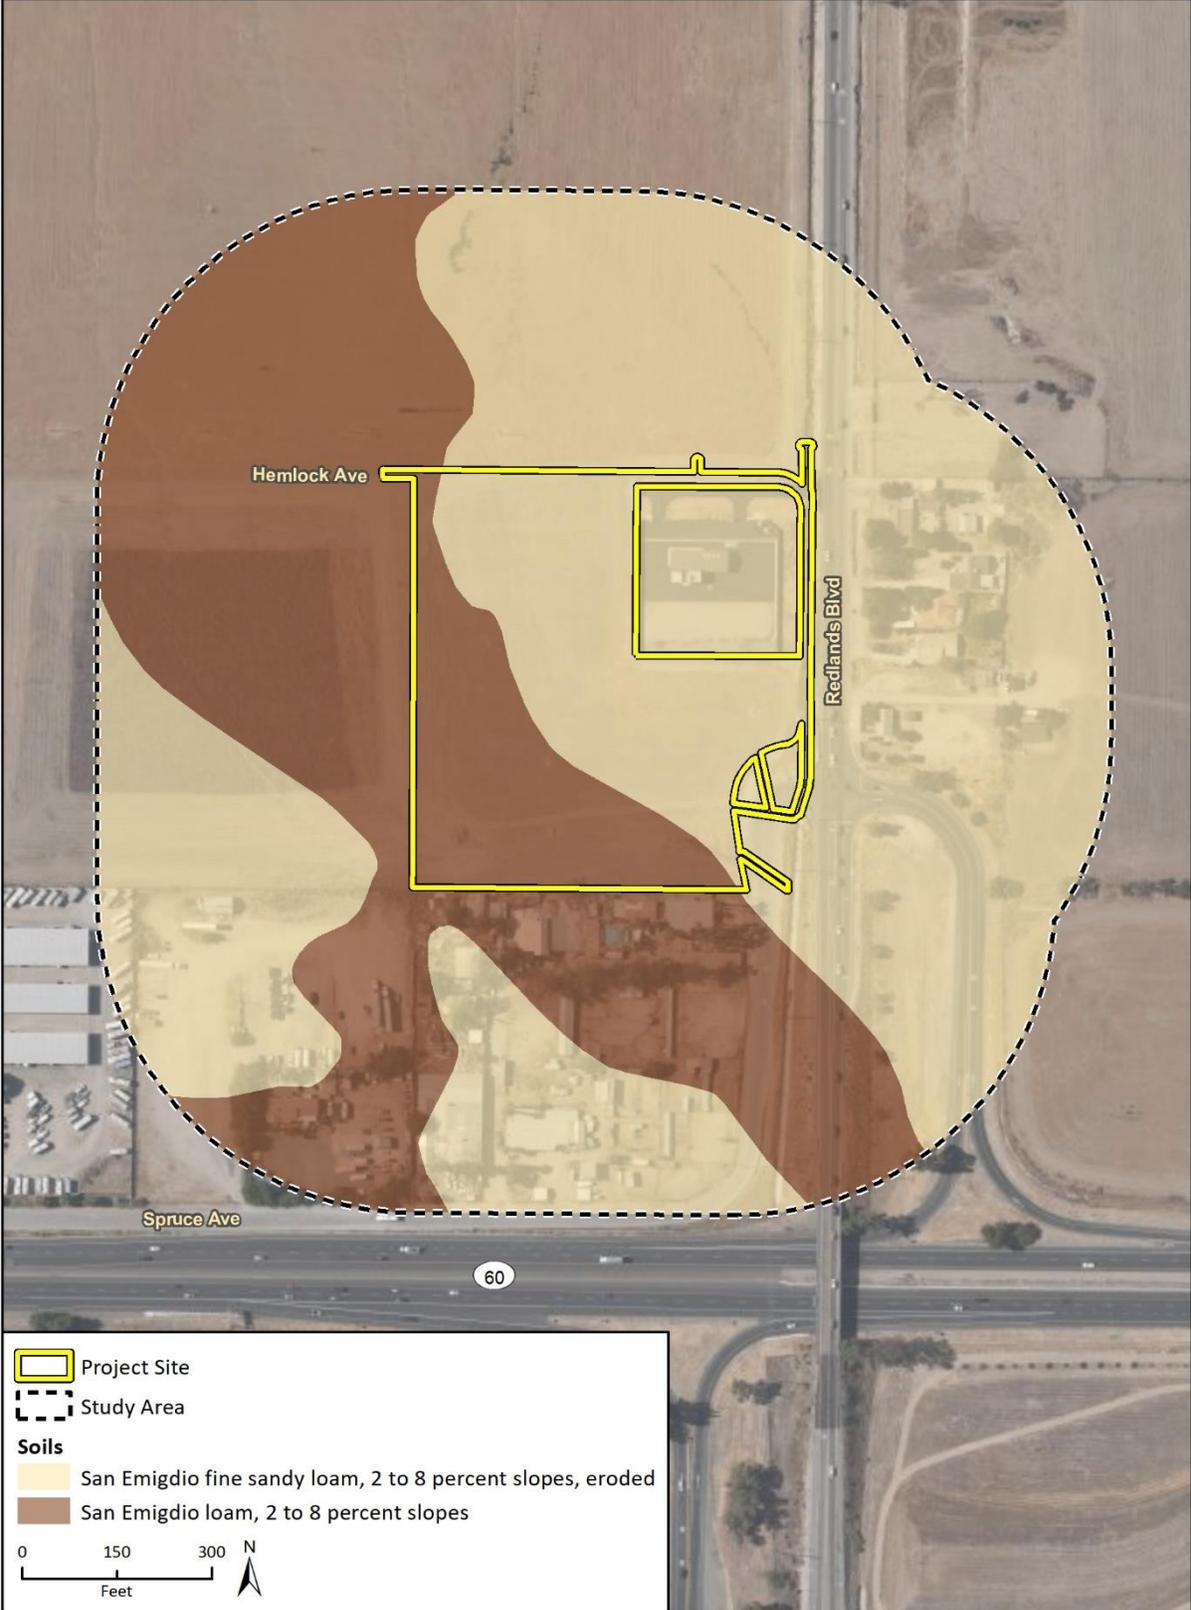
Figure 4 USDA Soils Map

The USDA NRCS Web Soil Survey identifies two soil map units in the project site (Figure 4) (USDA NRCS 2021a). These soil units are from the USDA NRCS Soil Survey of the Western Riverside Area, California, which was conducted on a broader scale than this study and did not necessarily include on site observations. The physical characteristics of the soil units, as described below, are general and not necessarily indicative of characteristics currently present within the study area. The soils on the site have been disturbed and likely no longer resemble the mapped soil types. None of these soils are considered hydric. The descriptions of the soil map units (USDA NRCS 2021c) are presented below.

Two soil types of the San Emigdio series occur on site: San Emigdio fine sandy loam, 2 to 8 percent slopes, eroded (SeC2) and San Emigdio loam, 2 to 8 percent slopes (SgC). The San Emigdio series consists of very deep, well drained soils that form in dominantly sedimentary alluvium. They are found on fans and floodplains and typically have low slopes. They are used for growing citrus fruit, alfalfa, and dryland grain and uncultivated areas are typically annual grasses and forbs (USDA NRCS 2021c). Soils on site have been tilled in the past for agricultural purposes.

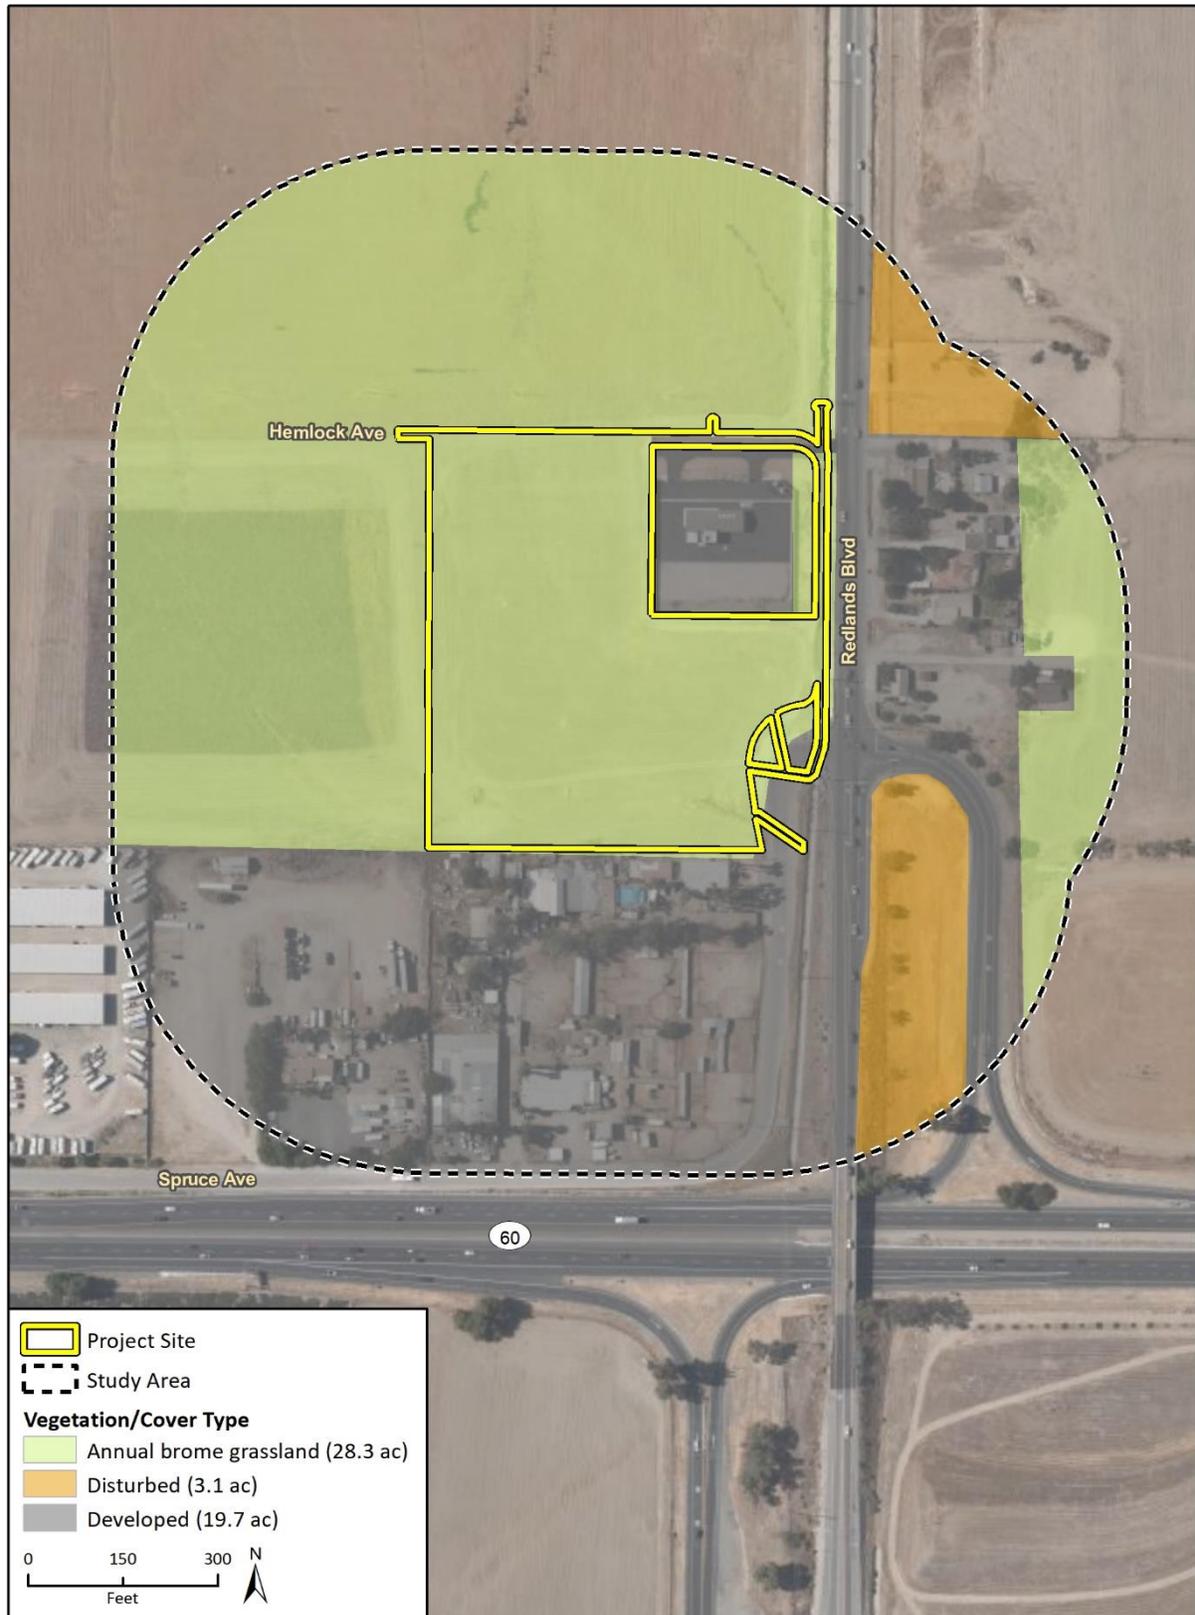
Figure 5 Vegetation Communities and Land Cover Types

Three vegetation communities/land cover types occur within the study area: *Avena* spp. - *Bromus* spp. Herbaceous Semi-Natural Alliance wild oats and annual brome grasslands, Developed, and Disturbed areas (Figure 5). A list of plant species observed within the project site is included as Appendix C.

Annual brome (*Bromus* spp.) grasslands are annual non-native grasslands with more than 60% of the herbaceous layer consisting of *Bromus* species. The entire project site consists of land that is regularly disturbed by tilling, resulting in annual brome grassland as the only habitat on site. Species diversity is limited, with only annual grassland species observed including red brome (*Bromus rubens*), ripgut brome (*Bromus diandrus*), foxtail barley (*Hordeum murinum*), Rancher's fiddleneck (*Amsinckia menziesii*), and short-pod mustard (*Hirschfeldia incana*). Annual brome grassland comprises 28.3 acres in the study area.

Developed areas within the study area are comprised of residences and commercial centers, as well as associated ornamental vegetation and the Redlands and Hemlock booster station. Developed areas comprise 19.7 acres in the study area.

Disturbed areas within the study area are comprised of very little grassy and ruderal vegetation and contain bare ground that has been mechanically disturbed. Disturbed areas comprise 3.1 acres in the study area.

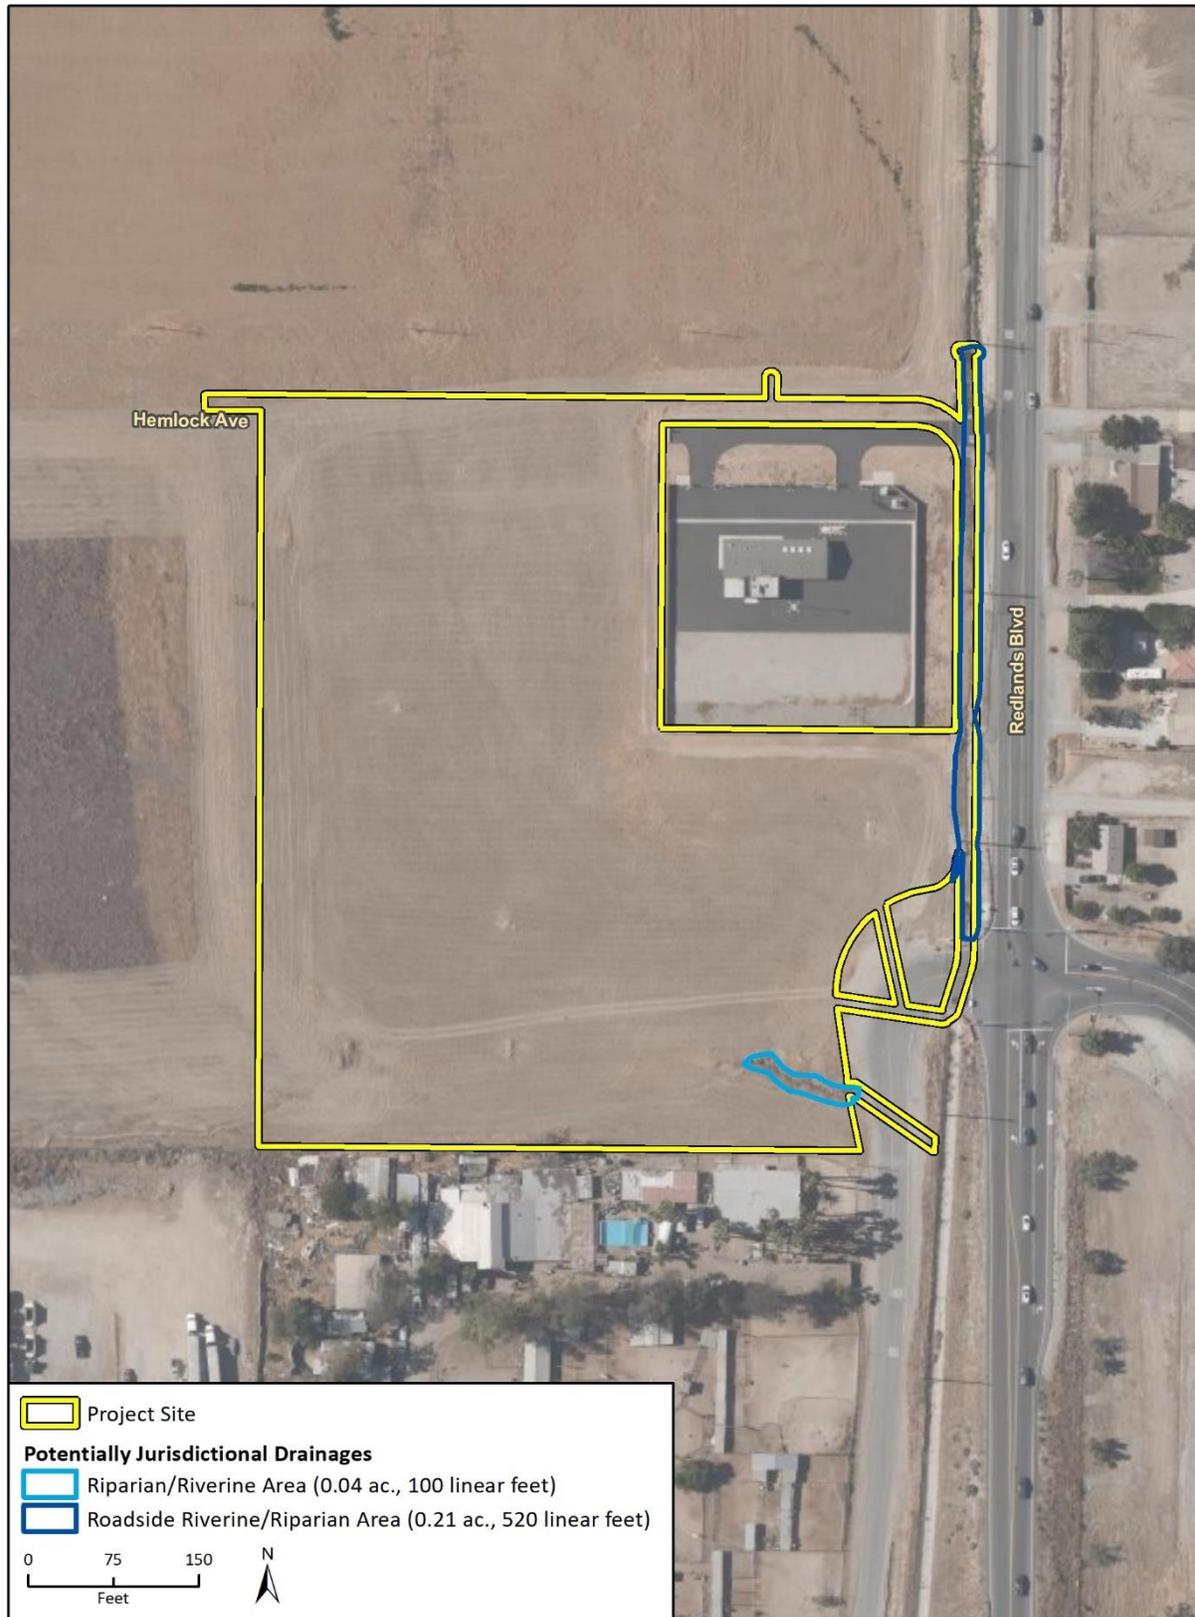
Figure 6 MSHCP 6.1.2 Riparian/Riverine Resources

The two drainage features on the project site are considered riverine (Figure 6). These features do not contain habitat dominated by trees, shrubs, persistent emergents, or emergent mosses and lichens, which occur close to or depend on a nearby freshwater source. The two features contain upland, non-riparian/riverine vegetative species and do not contain habitat for MSHCP Section 6.1.2 wildlife species. The features do contain a freshwater flow during a portion of the year, and they drain directly into an area that is described for conservation under the MSHCP or areas already conserved as they eventually convey flows via an underground storm drain system into downstream waters.

The riparian/riverine area in the roadside drainage channel is 0.21 acre and 520 linear feet. The riparian/riverine area in the erosional drainage ditch is 0.04 acre and 100 linear feet. The project site therefore comprises a total of 0.25 acre and 620 linear feet of riparian/riverine area.

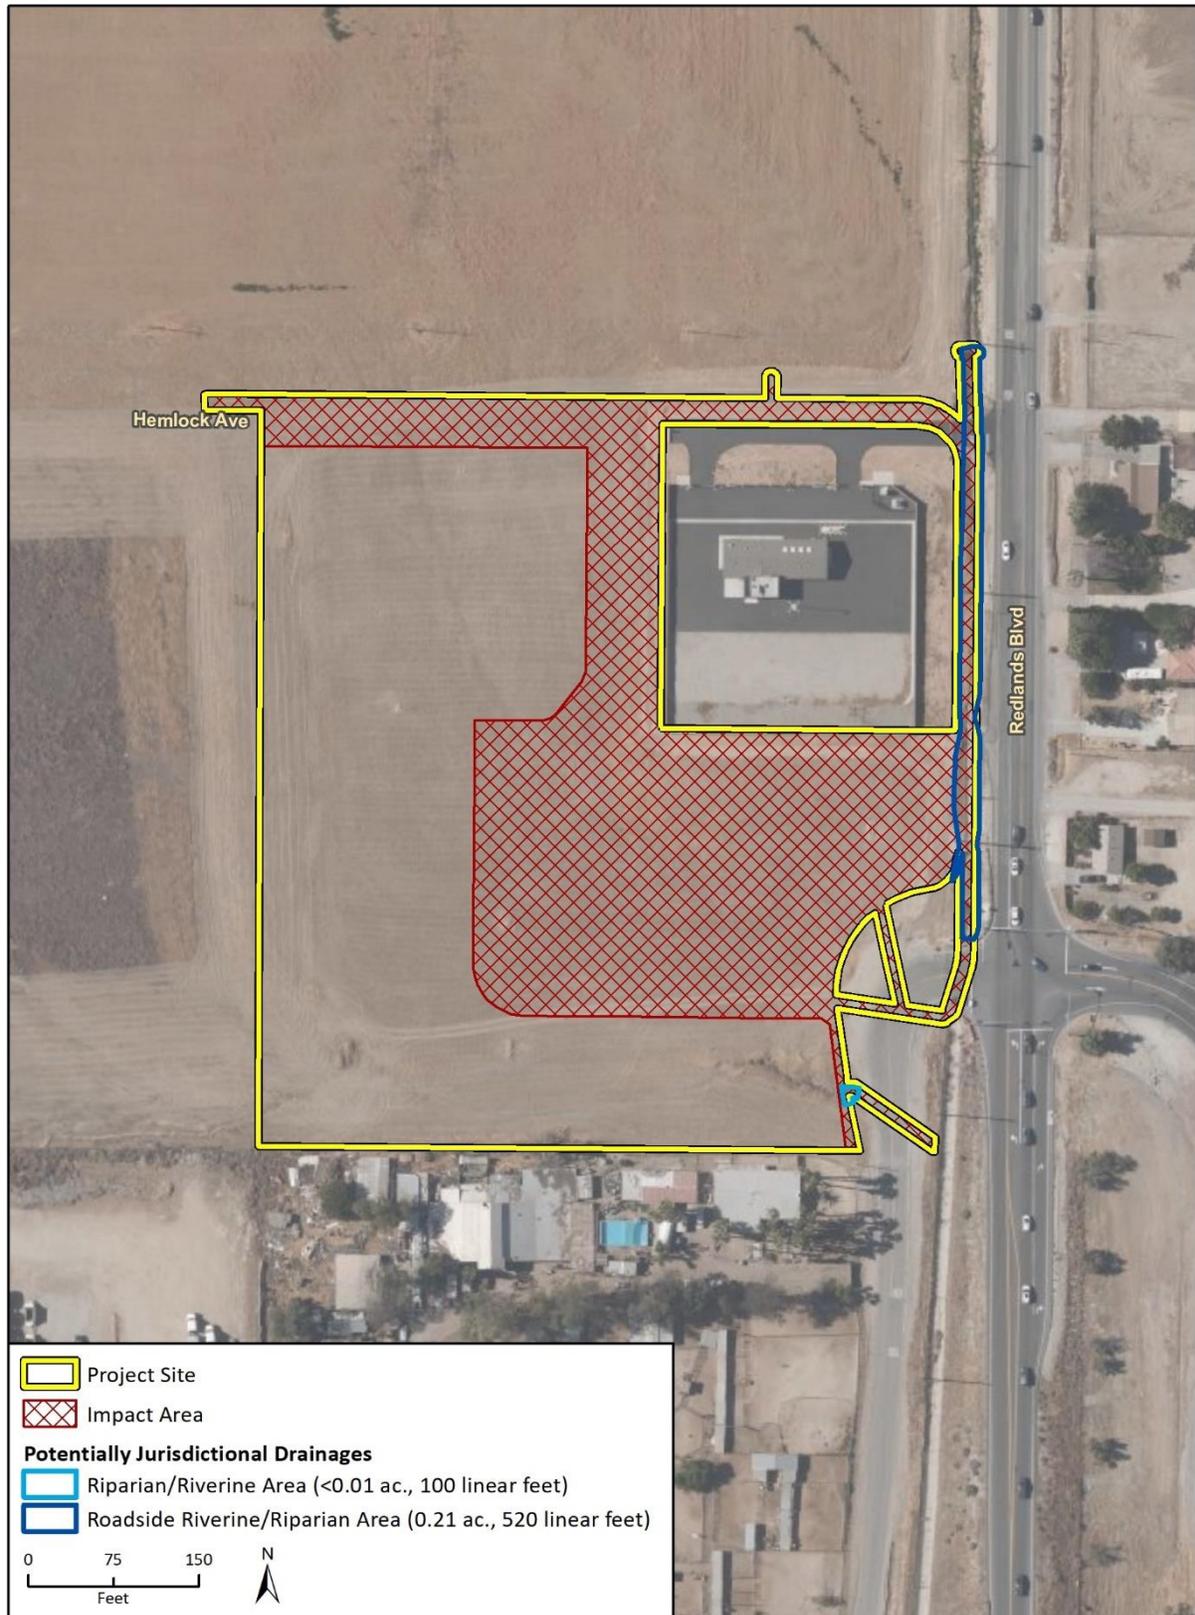
Figure 7 Impacts to Riparian/Riverine Resources

Project implementation would permanently impact 0.21 acre of riparian/riverine area in the roadside drainage channel and less than 0.01 acre of riparian/riverine area in the erosional feature (Figure 7). Total permanent impacts to riparian/riverine area are therefore 0.21 acre. No temporary impacts to riparian/riverine resources are anticipated, as the entirety of the roadside drainage channel would be converted to an underground storm drain and impacts to the erosional feature would be limited to the culvert under Spruce Avenue.

Compensatory mitigation for permanent impacts to riparian/riverine area would involve either purchase of establishment/re-establishment credits at a minimum 1:1 mitigation to impact ratio and/or rehabilitation credits at a 2:1 mitigation to impact ratio from the Riverpark Mitigation Bank, depending on availability of mitigation credits. To compensate for the permanent loss of 0.21 acre of riparian/riverine resources in the project site, the project applicant shall therefore either purchase 0.21 acre of establishment/re-establishment credits and/or 0.42 acre of rehabilitation credits from the Riverpark Mitigation Bank. A combination of re-establishment and rehabilitation credits may also be utilized as necessary and as approved by the Wildlife Agencies (CDFW and USFWS). This compensatory mitigation shall be implemented prior to ground disturbance associated with project construction activities. In accordance with Section 6.1.2 of the MSHCP, a Determination of Biologically Equivalent or Superior Preservation (DBESP) will be prepared and will describe the project impacts and proposed mitigation in more detail.

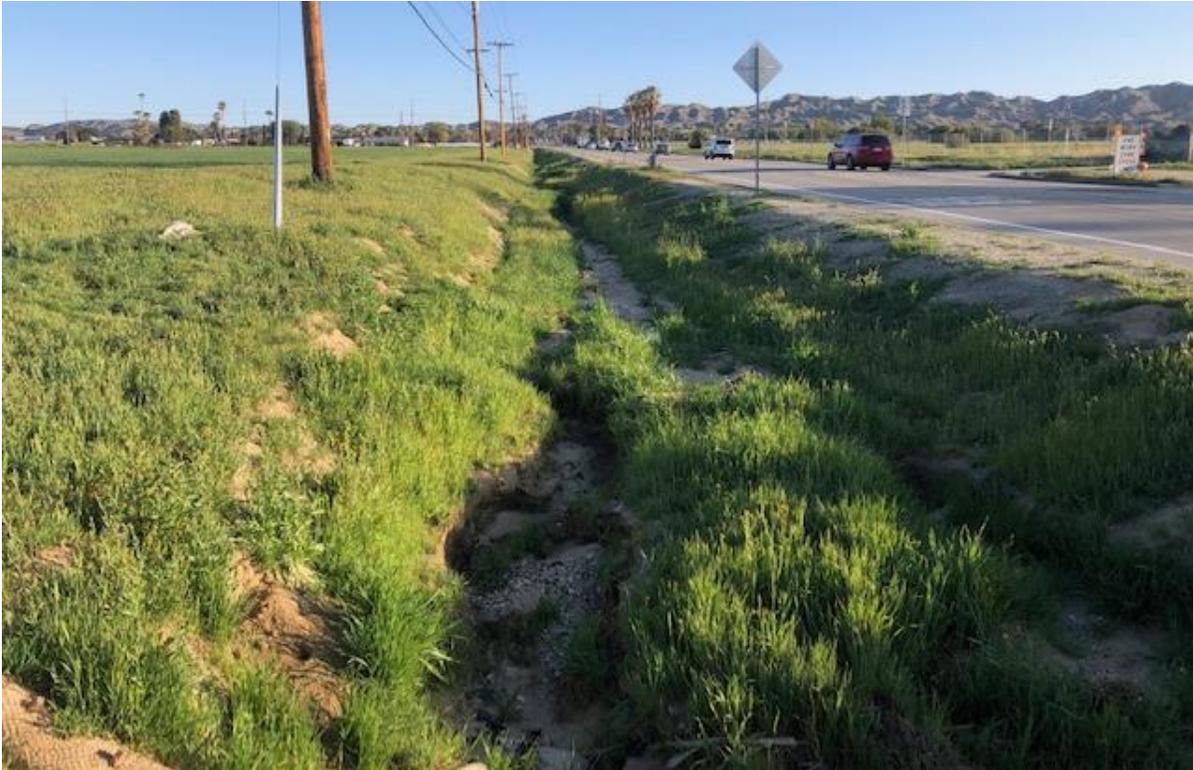
Photograph 1. Facing north west of Redlands Boulevard looking at the roadside drainage ditch.

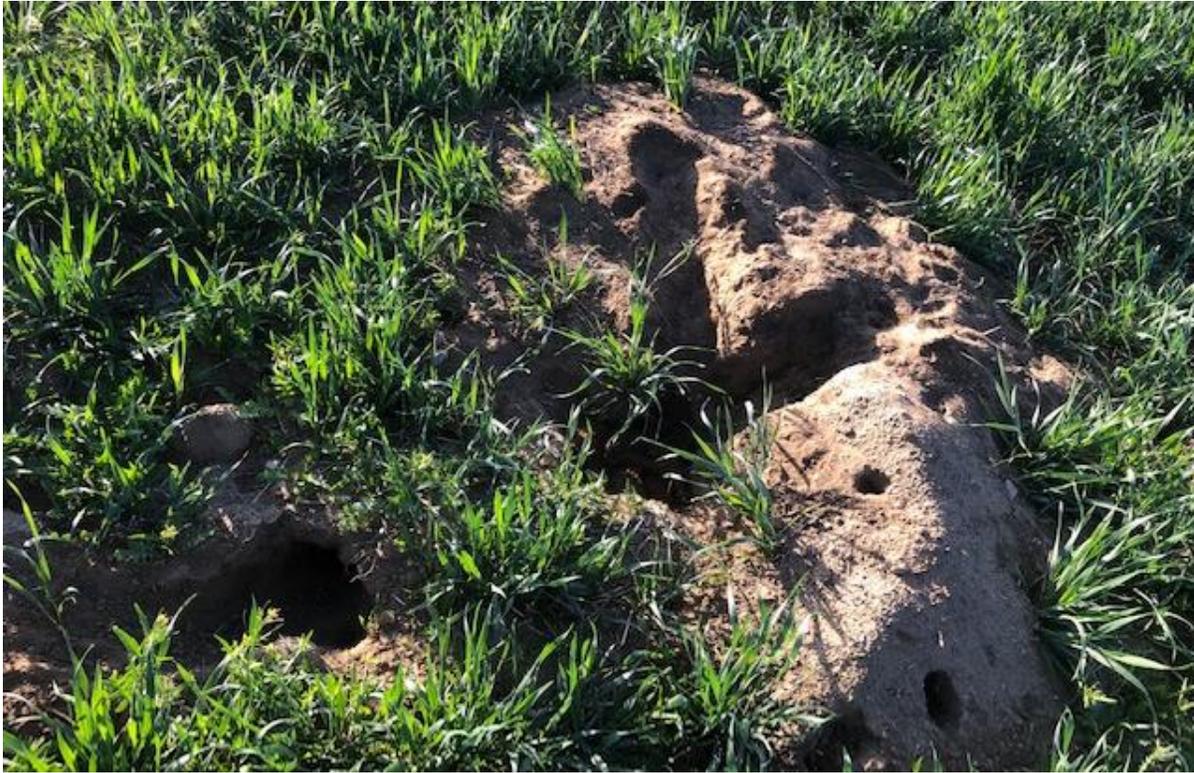
Photograph 3. Representative ground squirrel burrows found throughout the study area.

The MSHCP requires pre-construction surveys for BUOW to be conducted in all areas of suitable habitat. Since the entire site consists of suitable habitat, a preconstruction survey for BUOW by a qualified biologist will be required within 30 days prior to site disturbance.

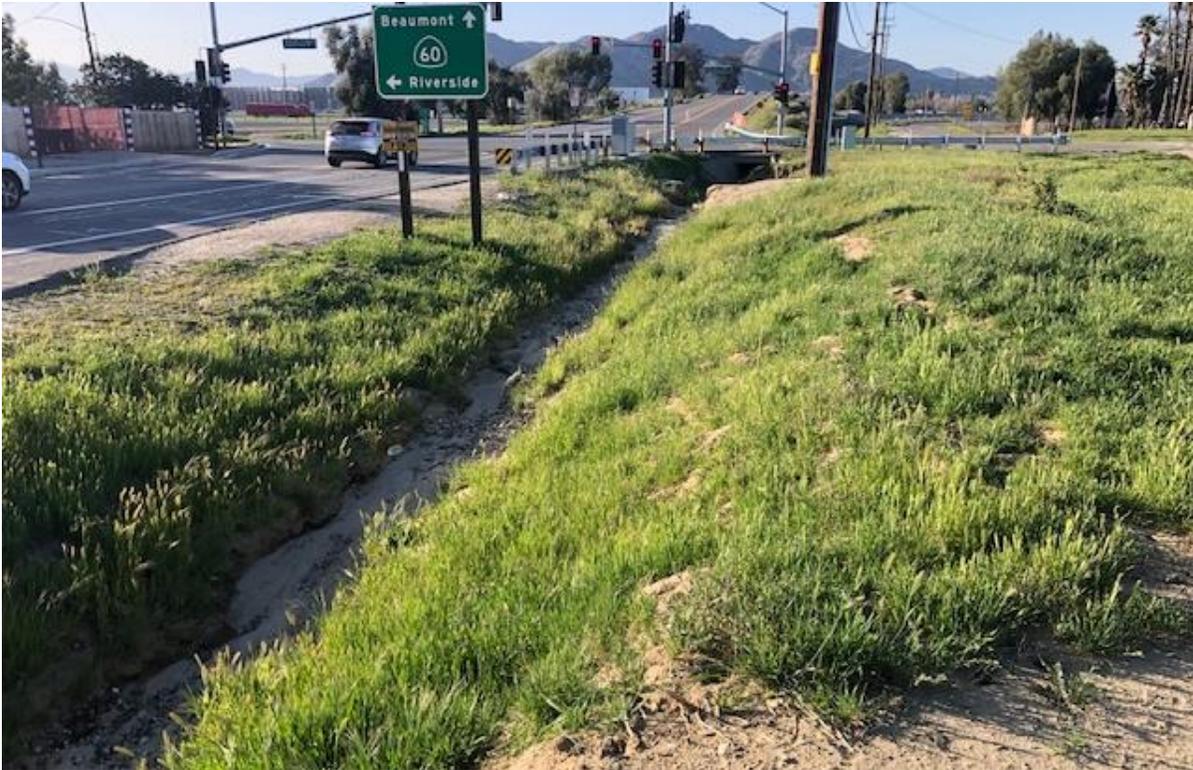
Photograph 5. Facing south and downstream at roadside drainage ditch.

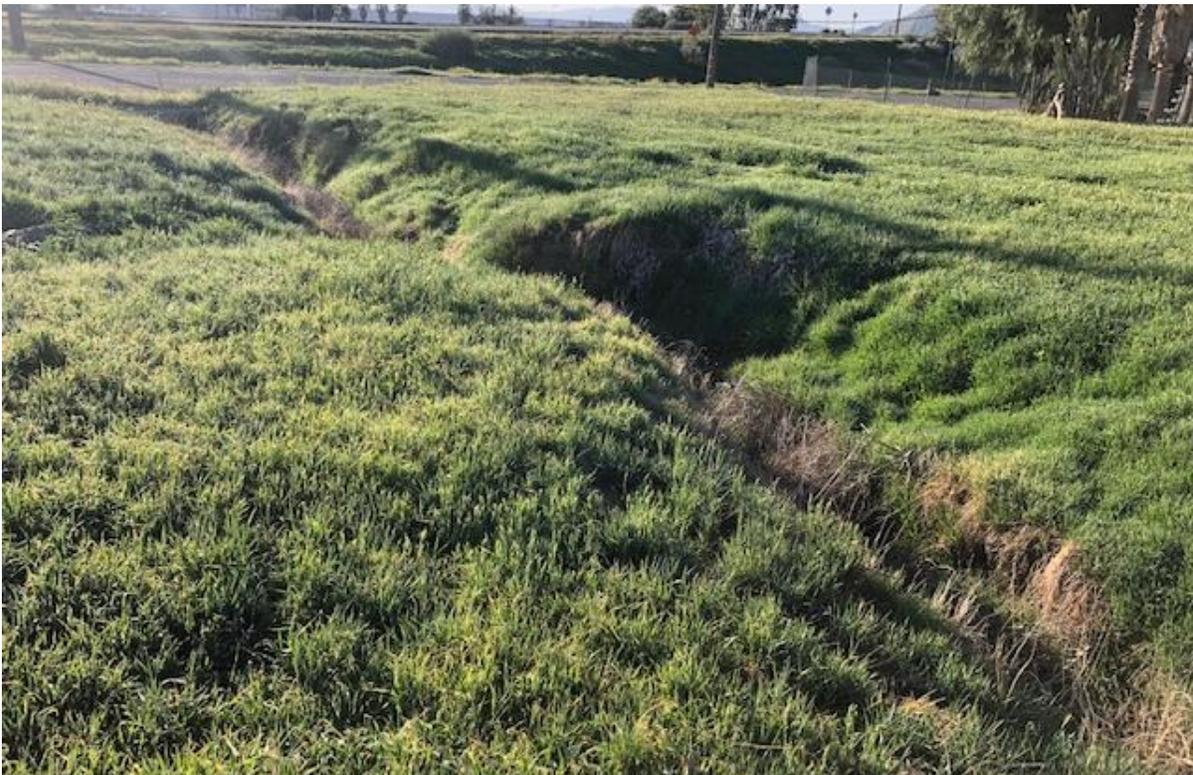
Photograph 6. Downstream, southeast-facing view of erosional feature toward Spruce Ave.

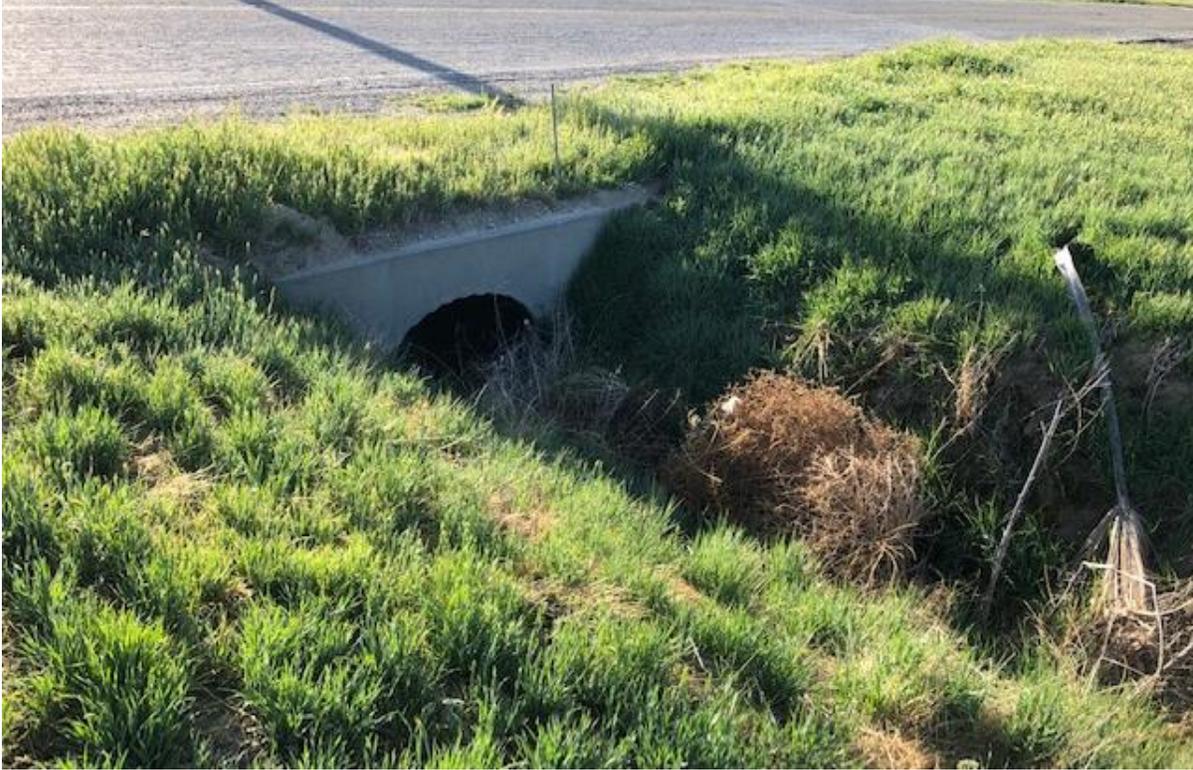
Photograph 7. Showing where the erosional drainage feature meets the culvert under Spruce Avenue.
